Rimkus Consulting Group, Inc.
Eight Greenway Plaza, Suite 500
Houston, TX 77046
(800) 580-3228 Telephone
(713) 623-4357 Facsimile

Re: RCG File No: 11009971
LLV Number: 0209452
VMF Location: 1530 Greensmark Drive in Houston, Texas
Subject: Final Report

Rimkus Consulting Group, Inc. was retained to examine LLV 0209452, VIN 1GBCS10E4M2908832. The fire occurred on June 13, 2016 at around 12:30 P.M. the operator of the vehicle at the time of the fire, was unavailable for interview but reportedly stated the vehicle's engine died while delivering mail on his route and backfired during subsequent attempts to restart it. Soon thereafter, smoke was observed from beneath the hood as well as flames.

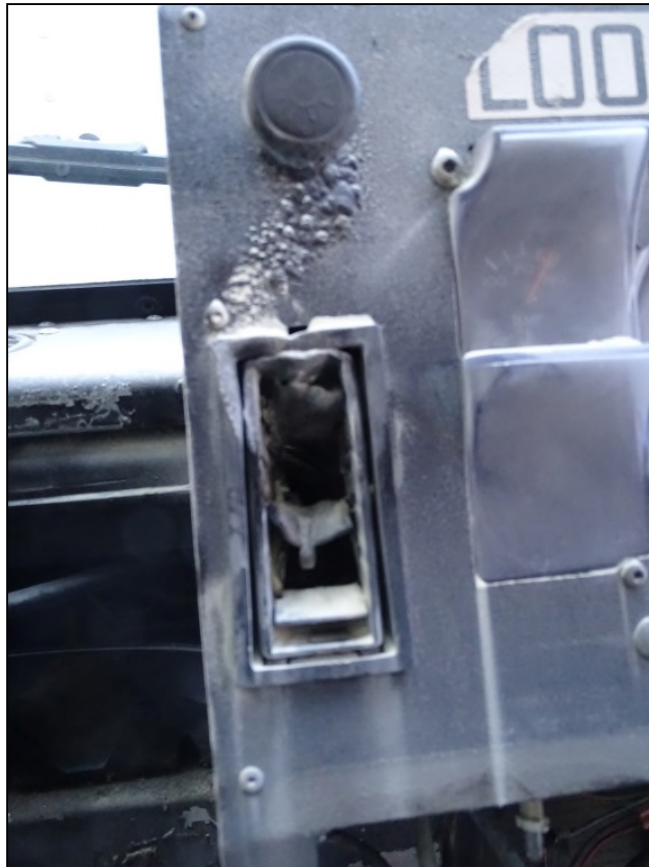
Photograph 1

Damage to dash and heater vent.

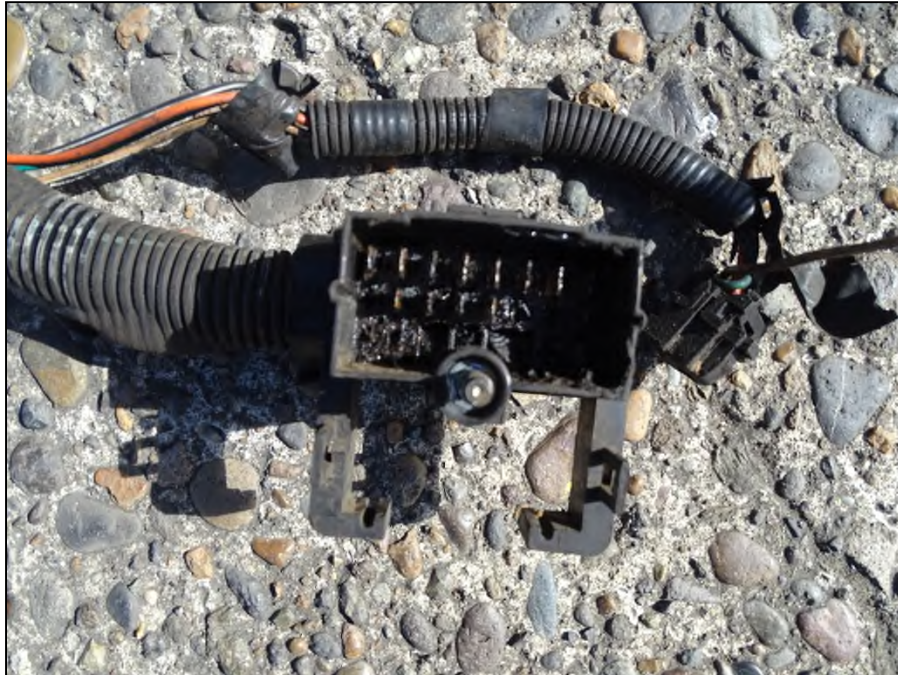
Photograph 2

Engine side of the fuse block connection.

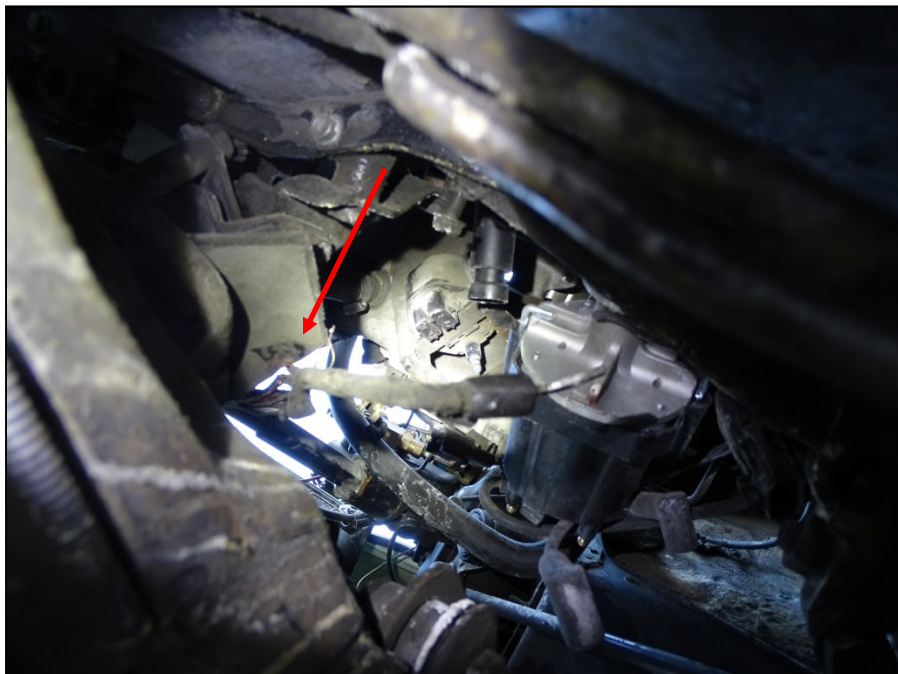
Photograph 3

Positive cable arced and welded to motor mount.

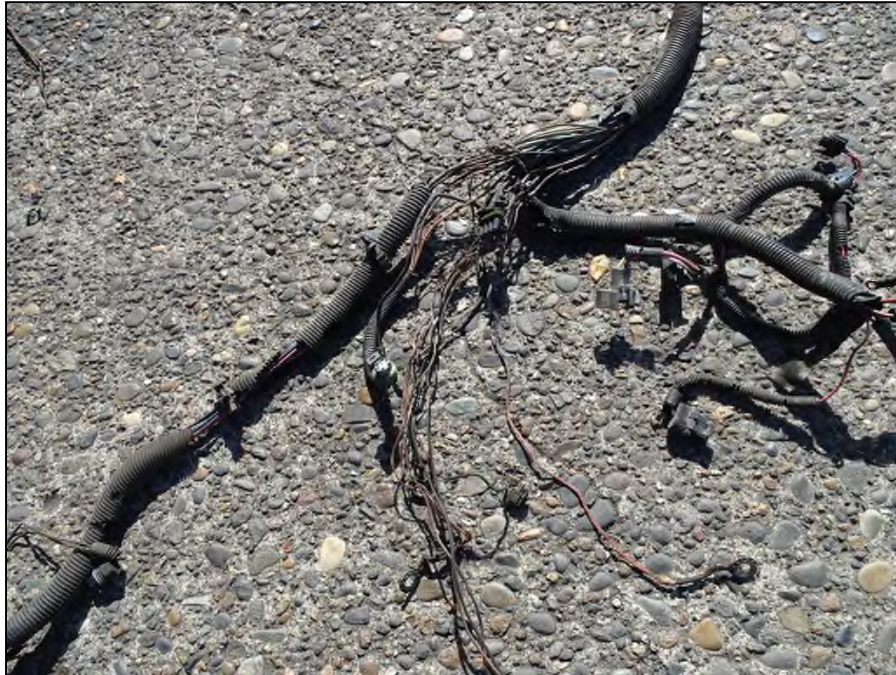
Photograph 4

Smaller wires of the primary engine harness with burned insulation.

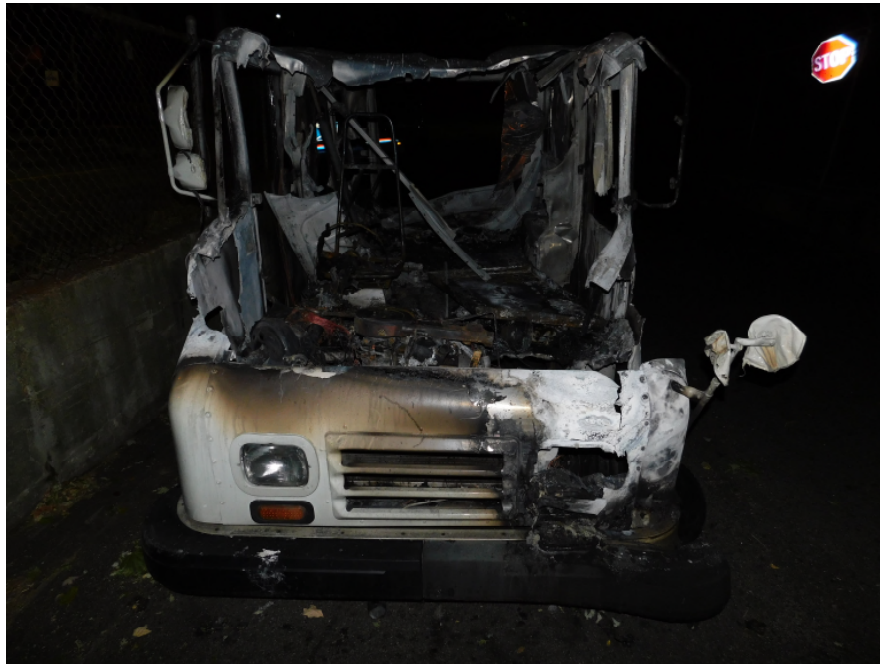
Photograph 1

Severe fire damage to the engine compartment (Photograph by USPS).

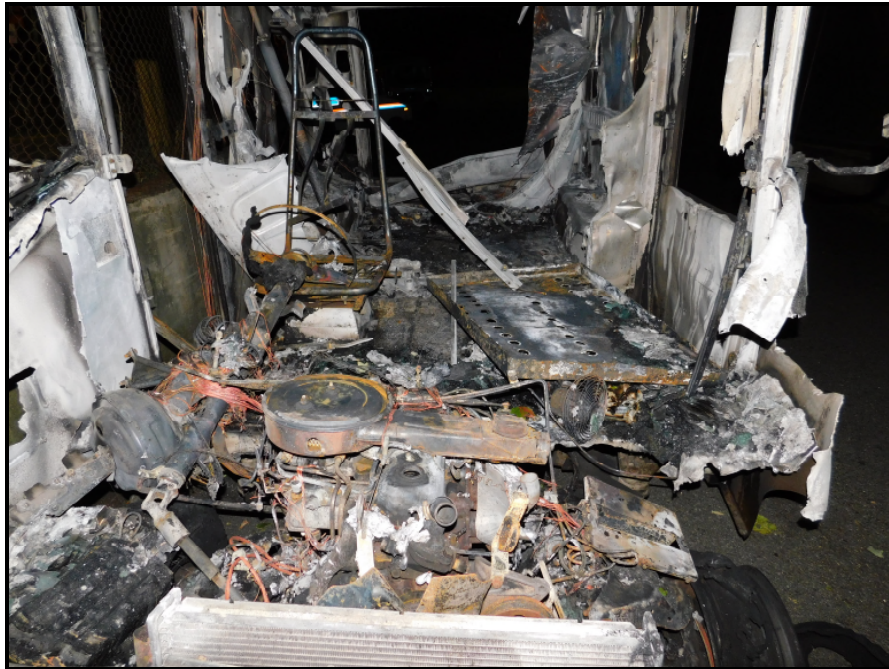
Photograph 3

Severe fire damage to the engine compartment and interior (Photograph by USPS).

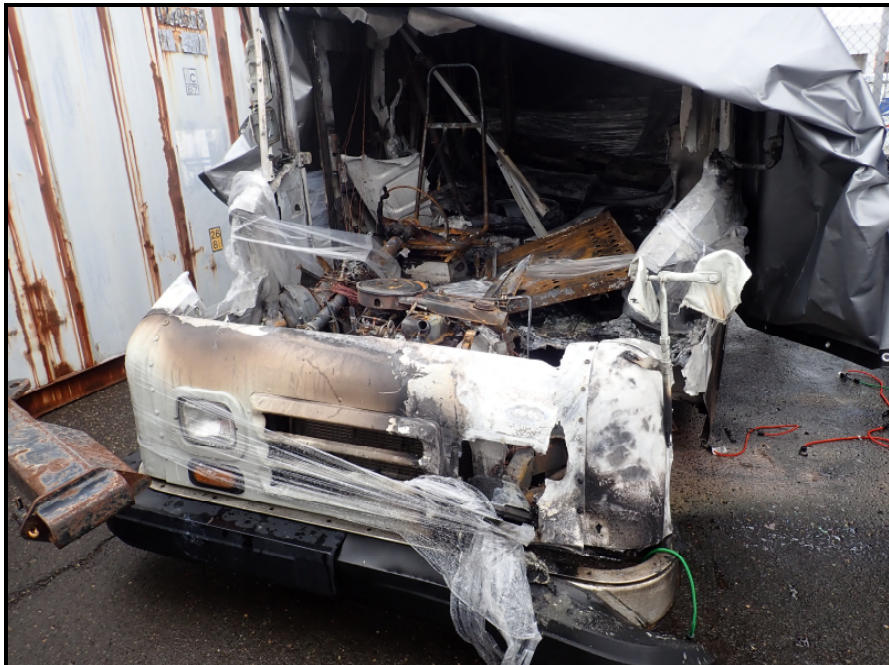
Photograph 4

Engine compartment fire.

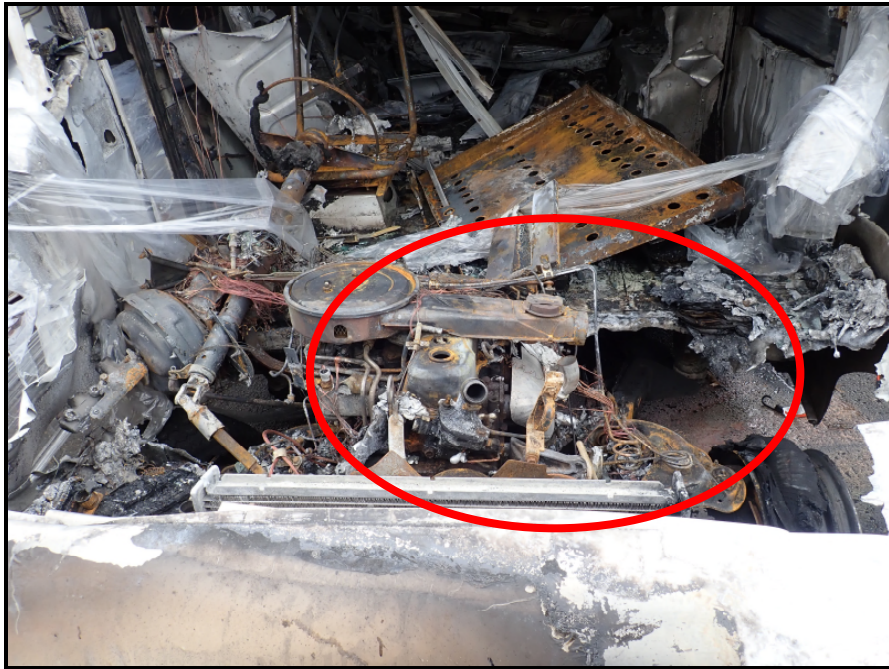
Photograph 5
Engine compartment origin.

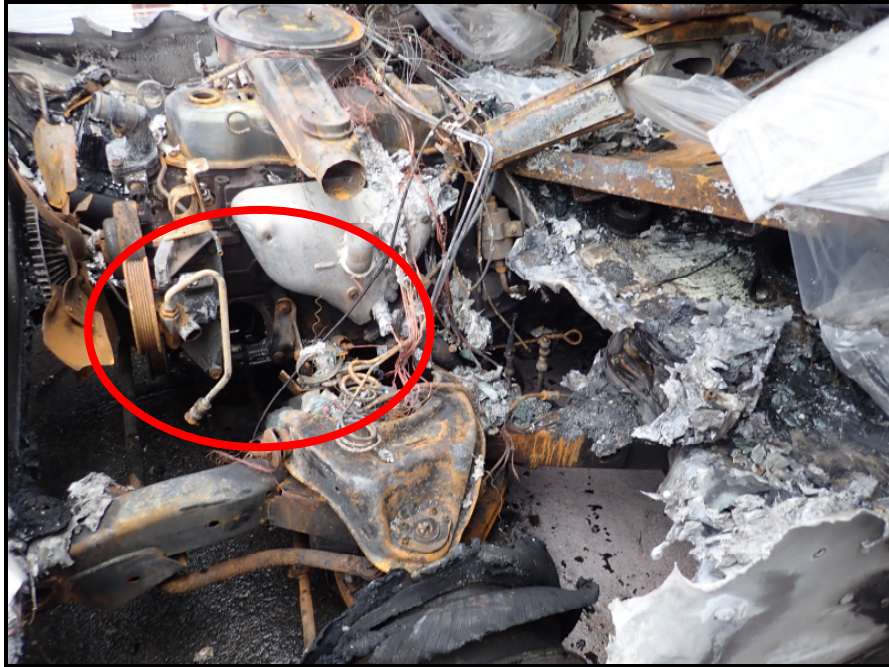
Photograph 7

Observe hole in engine block on mail side.

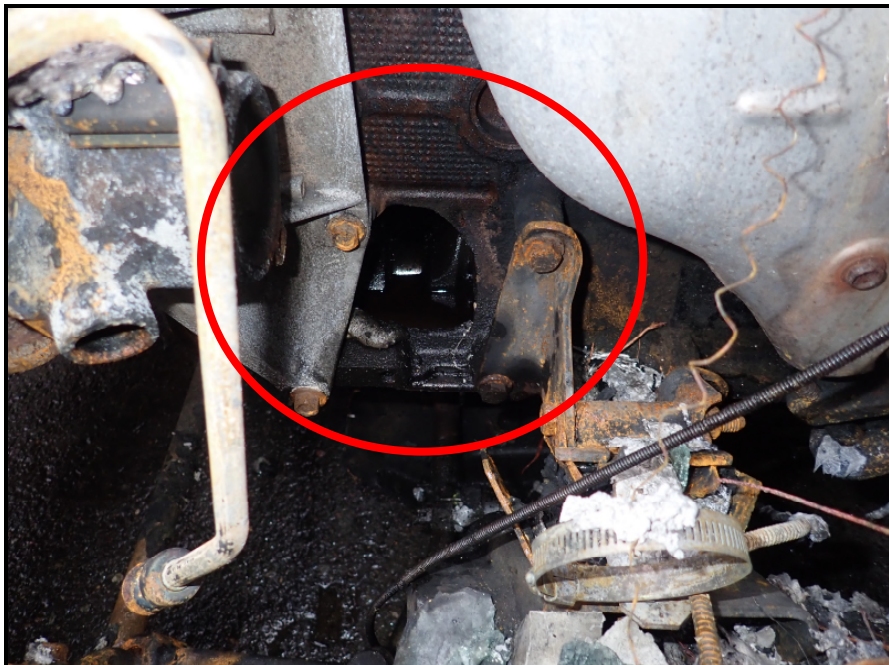
Photograph 8

Hole in engine block.

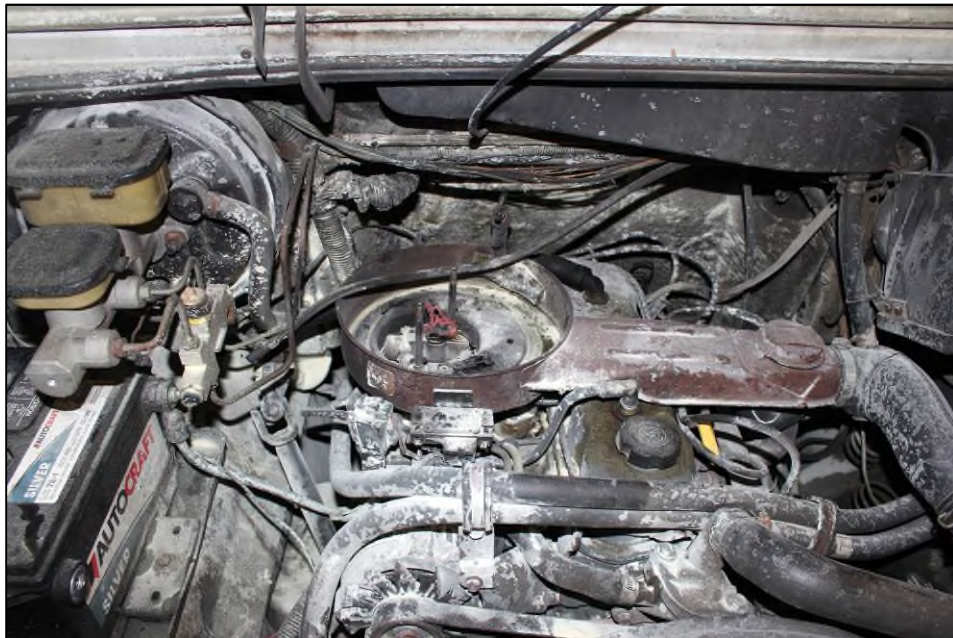
Photograph 6
Air filter and carburetor. Area of origin.

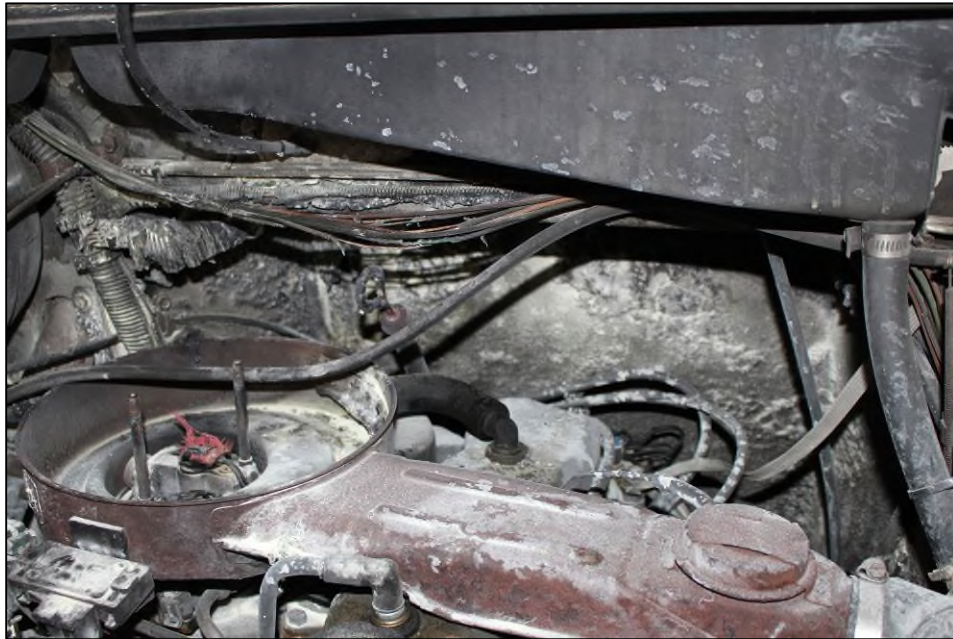
Photograph 7

Wires damaged by fire above air filter.

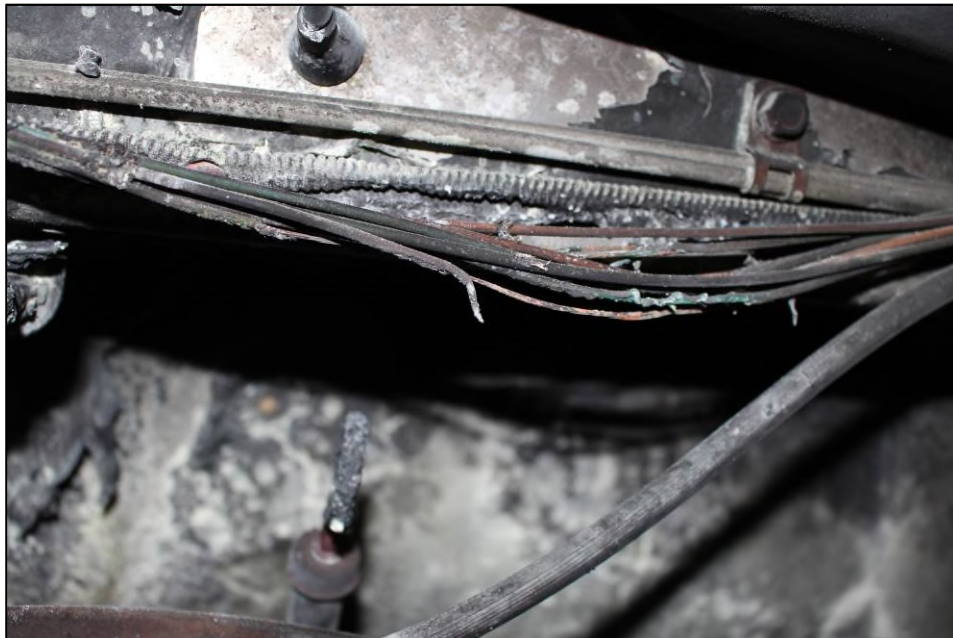
Photograph 8

Wires damaged by fire above air filter.

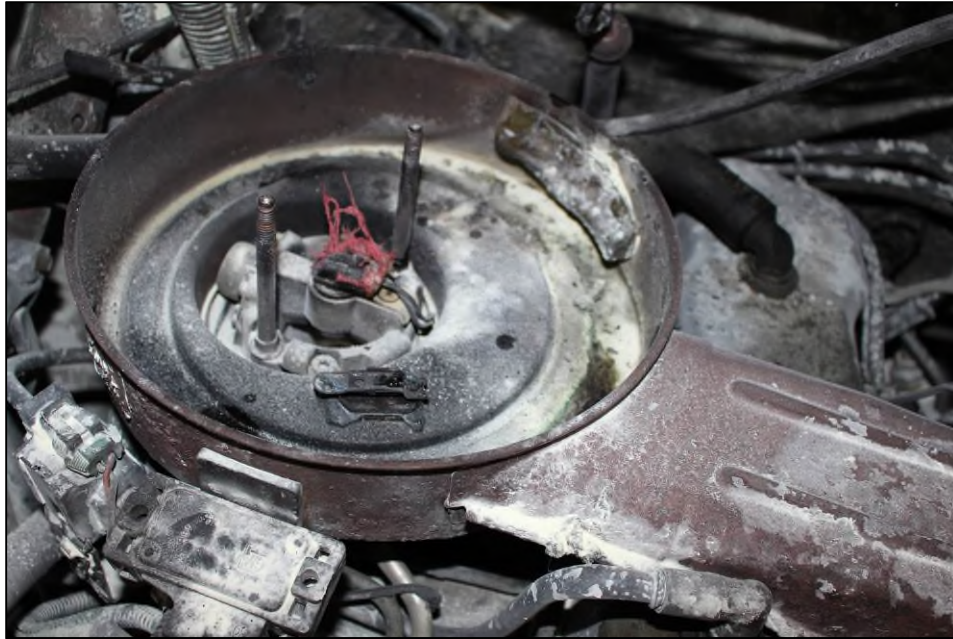
Photograph 9

Shop towel remains inside carburetor.

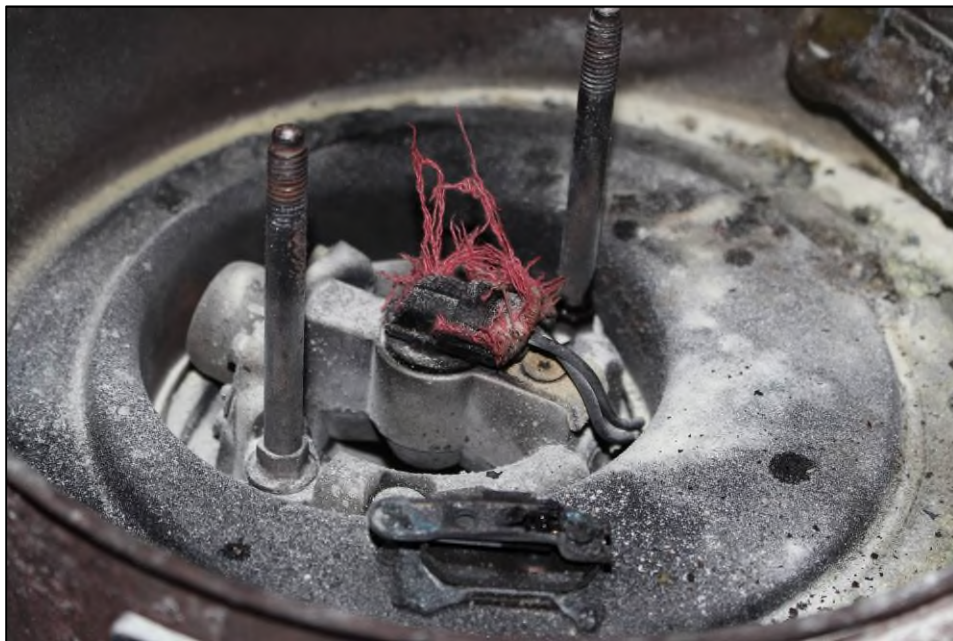
Photograph 10

Shop towel remains inside carburetor.

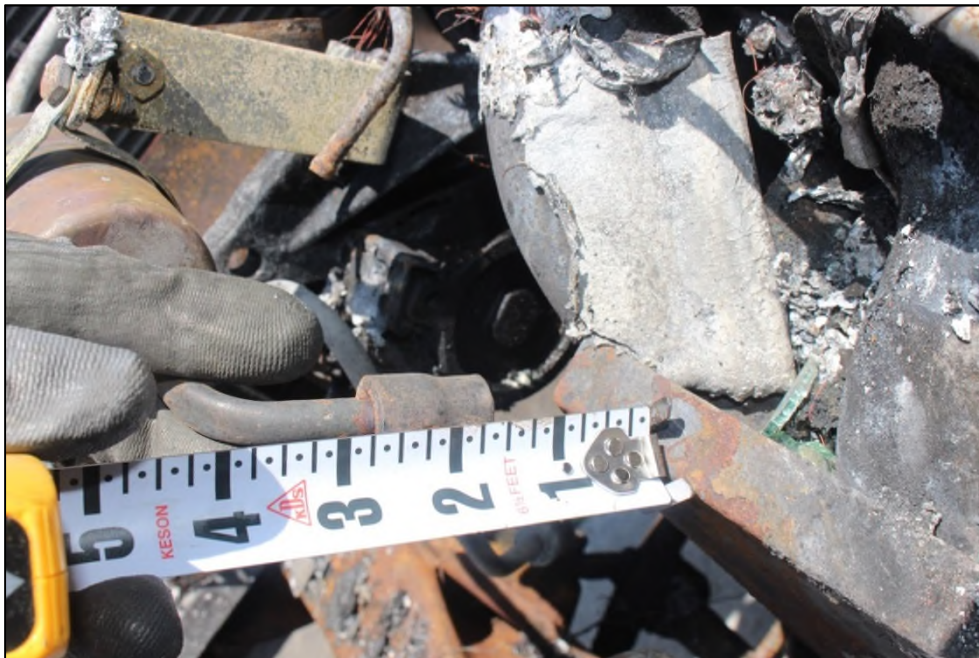
Photograph 4

Fuel line input connector angled towards exhaust manifold and metal shroud.

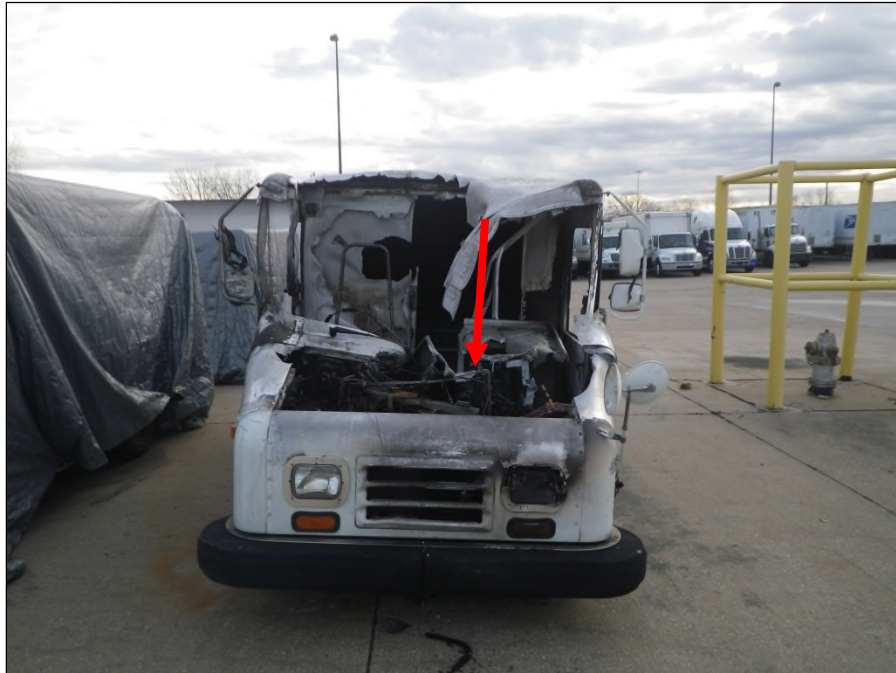
Photograph 1

Front view of fire-damaged LLV. Arrow is area of origin.

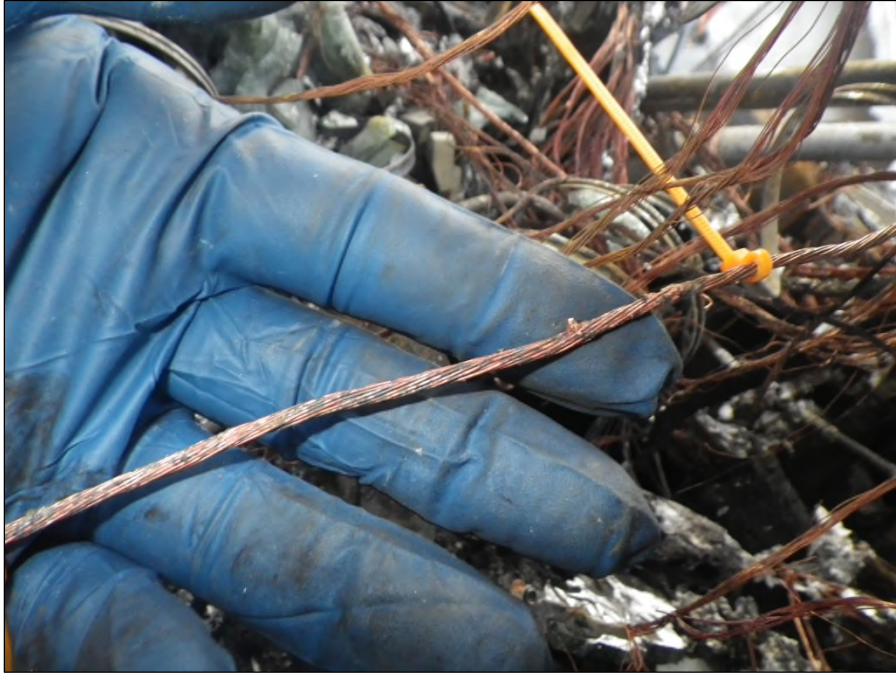
Photograph 3

View of electrical activity on red conductor in wiring harness above steering wheel.

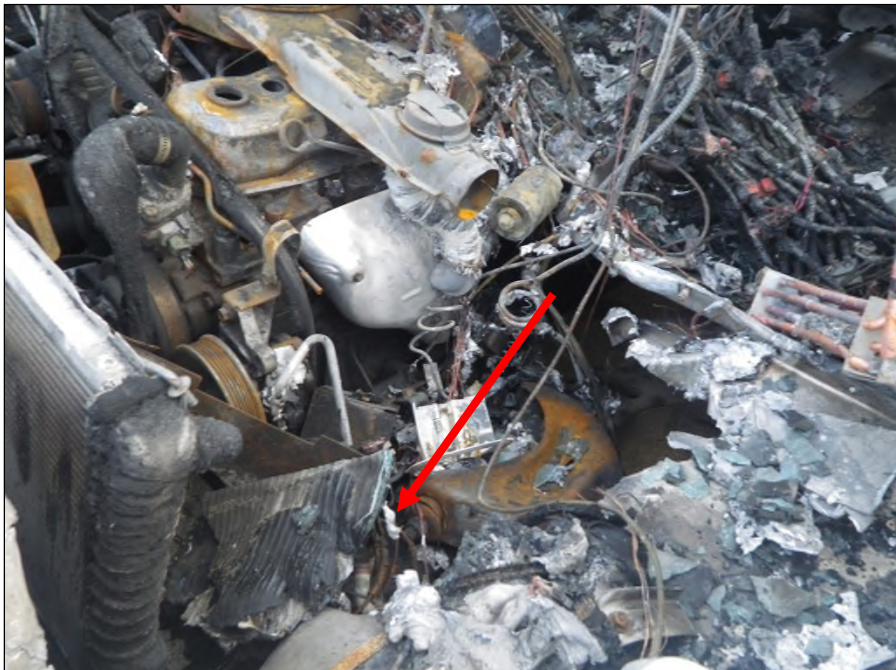
Photograph 4

View of engine compartment above area of origin. Arrow indicates area of origin.

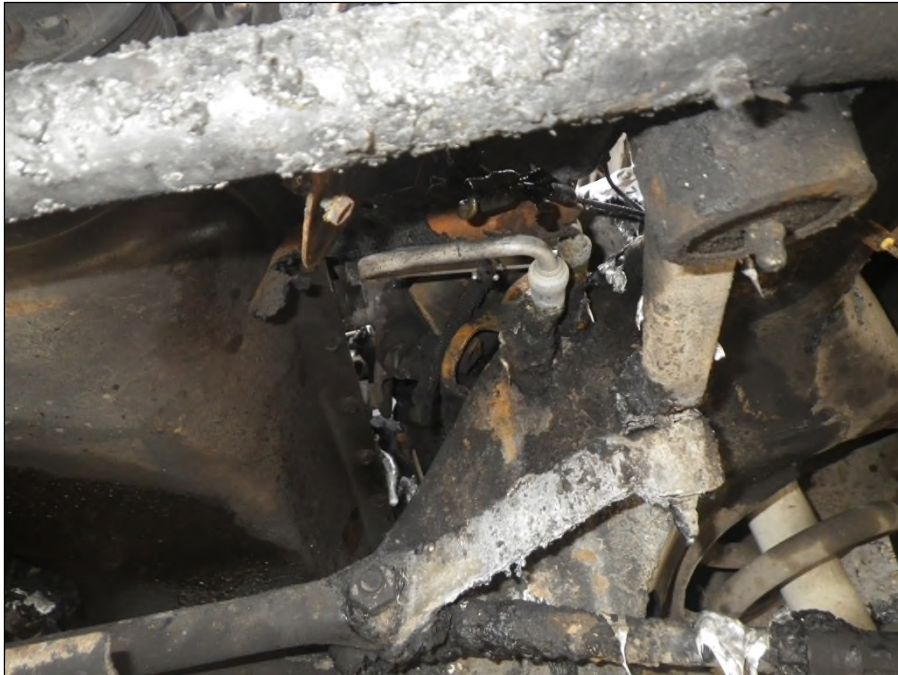
Photograph 5

View of two fuel lines in area of origin.

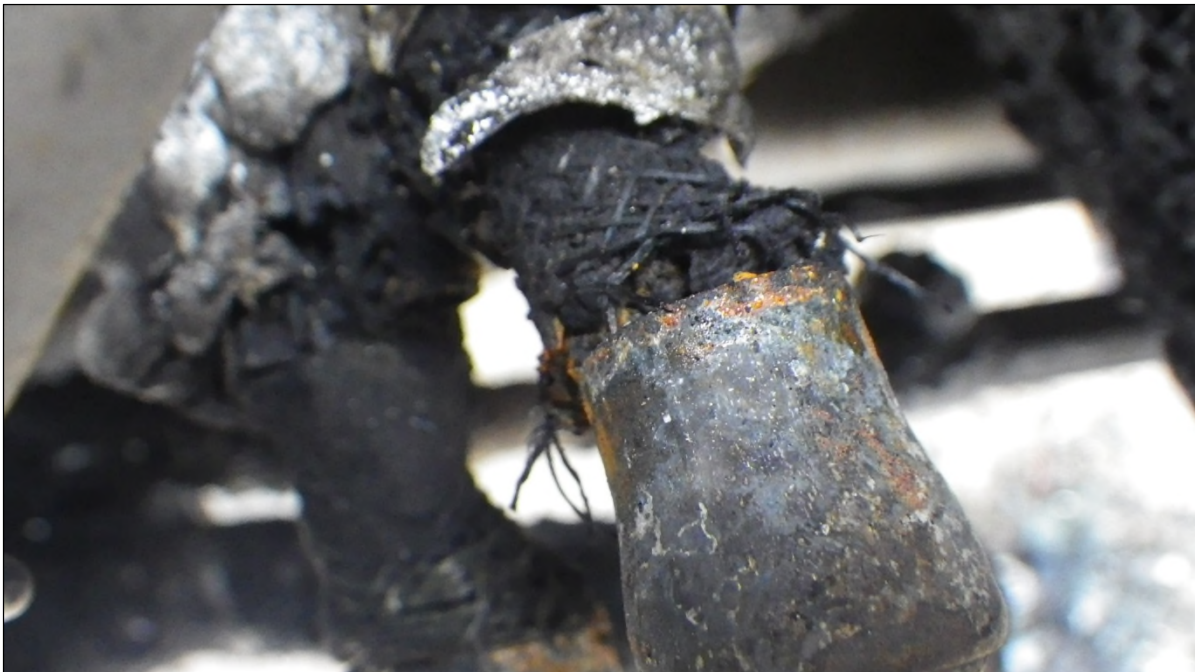
Photograph 6

Zoomed in view of separated fuel line in area of origin.

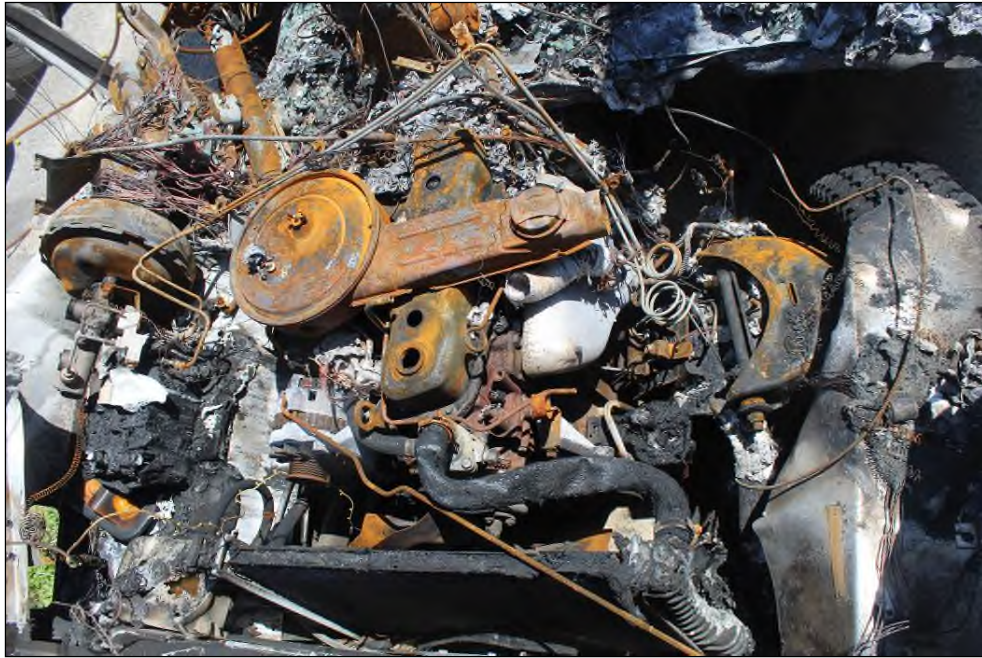
Photograph 5

View of fire damaged engine.

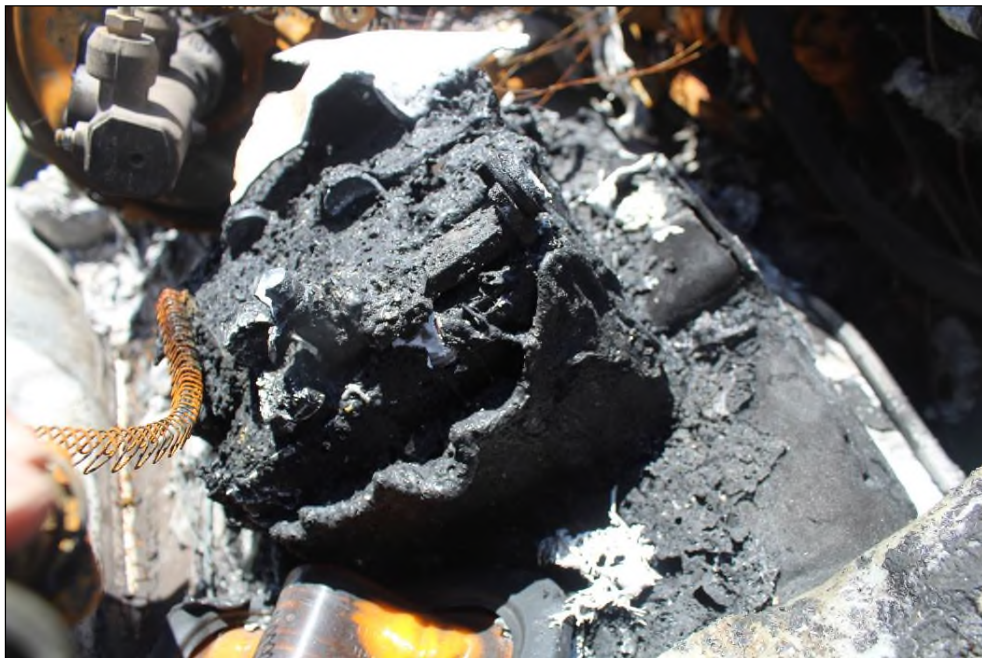
Photograph 6

View of fire damaged battery from engine compartment.

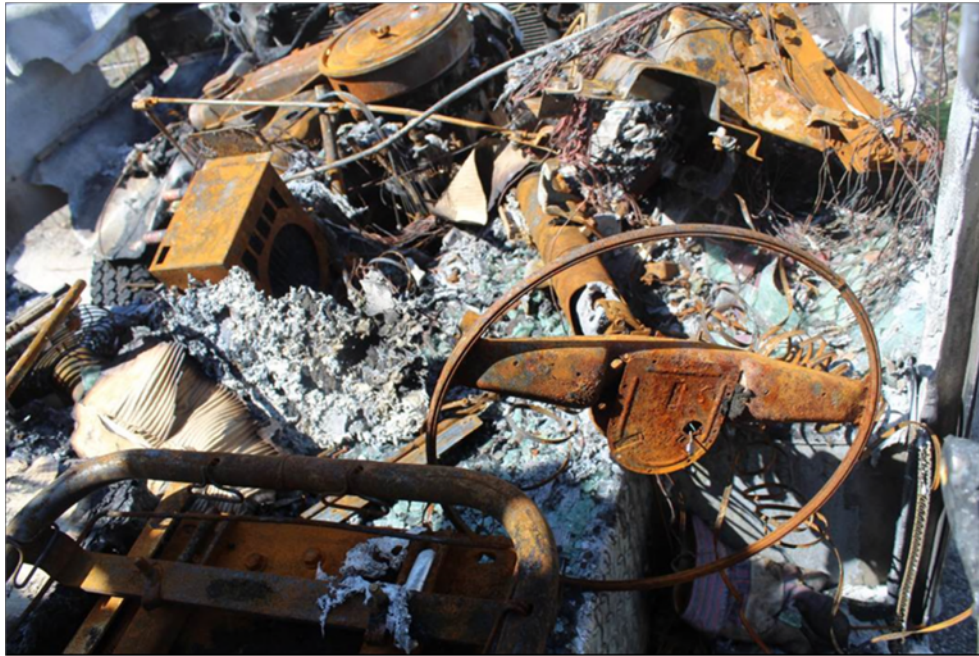
Photograph 7

View of bulkhead and dashboard on driver's side of vehicle.

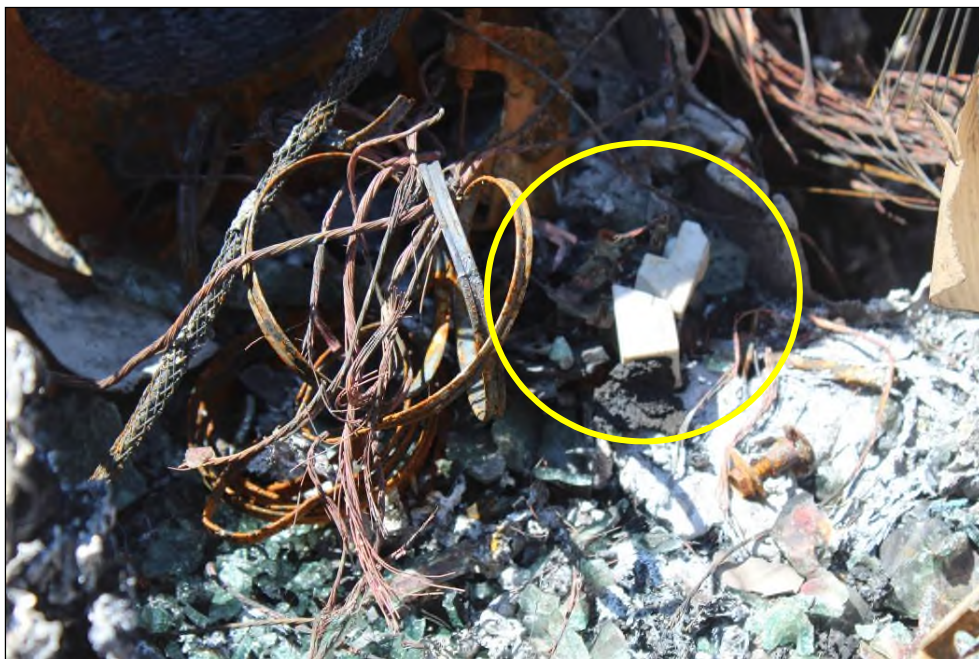
Photograph 8

View of floor beneath steering column showing remains of light switch.

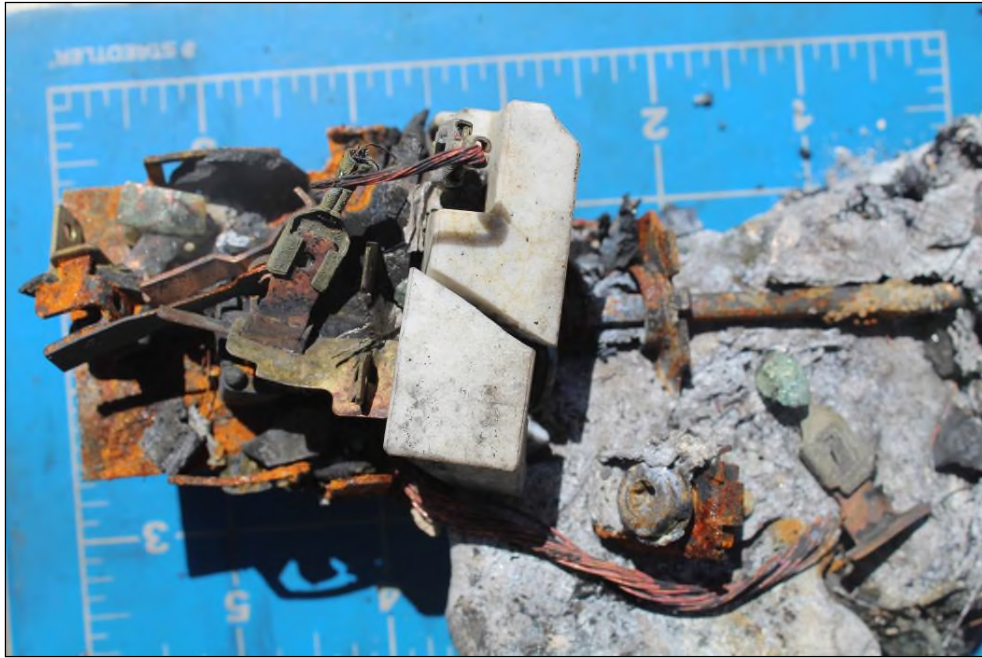
Photograph 9

Close up view of remains of light switch.

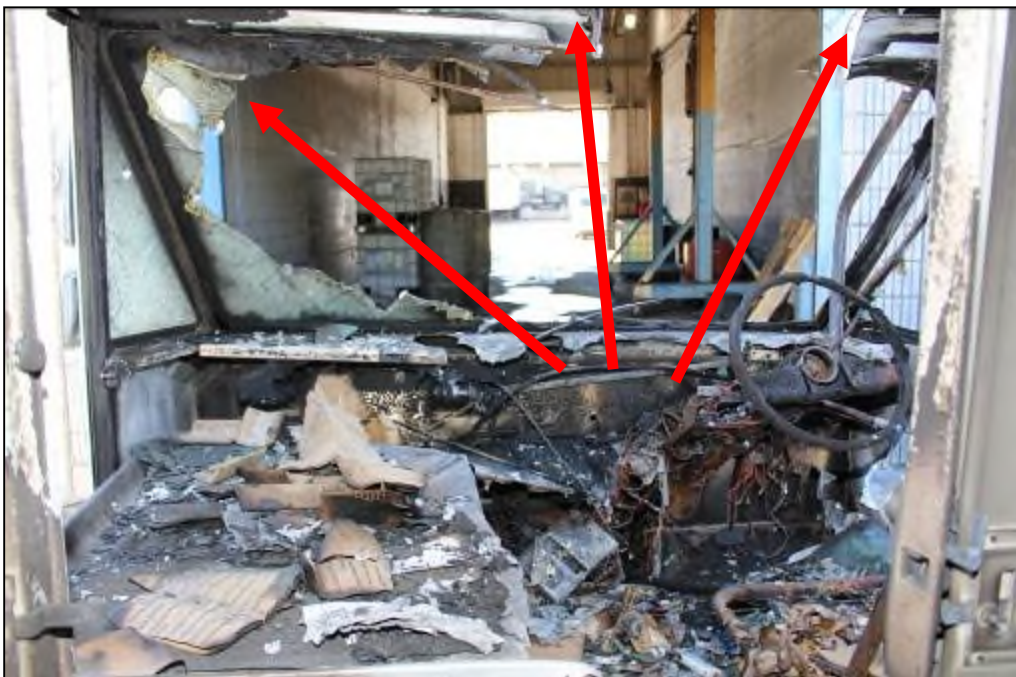
Photograph 6

Examination of the interior of the vehicle revealed the most severe fire damage had occurred to the dashboard area. Most of the combustible materials at the dashboard and in the passenger compartment area had been consumed during the fire. Electrical conductors in the passenger compartment were examined and there were no indications of adverse electrical activity.

View of the fire patterns in the passenger compartment.

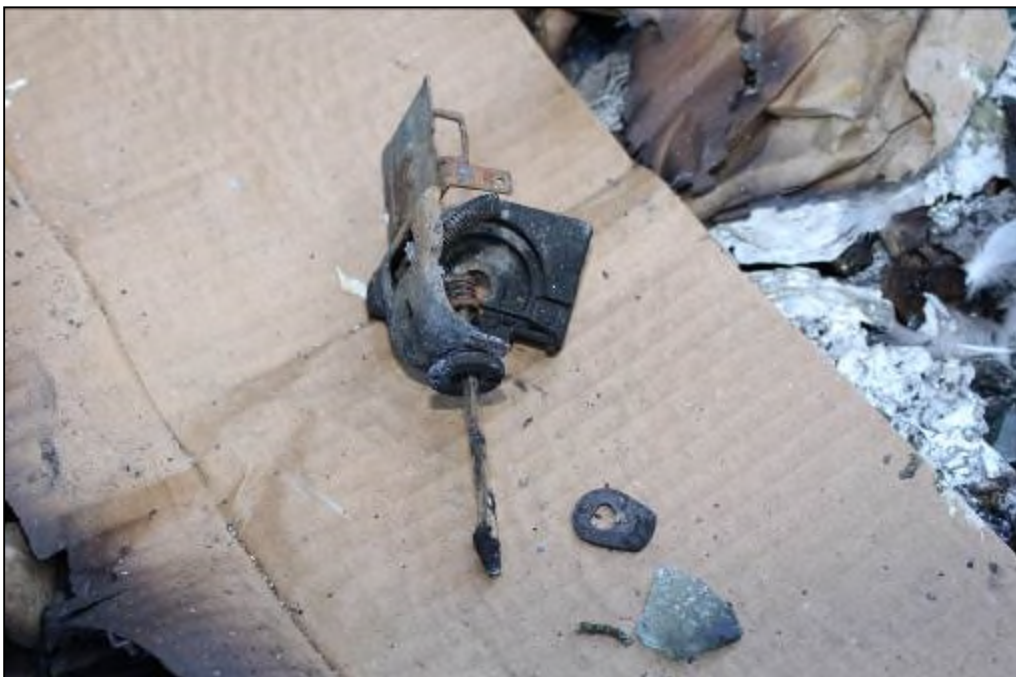
Photograph 8

3. The specific ignition sequence and cause of the fire was determined to be the failure of the headlamp switch, the most probable failure being the rheostat switch for the dimmer function which heated until the surrounding combustible materials were ignited.

Burned remains of the headlamp switch assembly were found on the driver's seat.

View of the burned remains of the headlamp switch assembly.

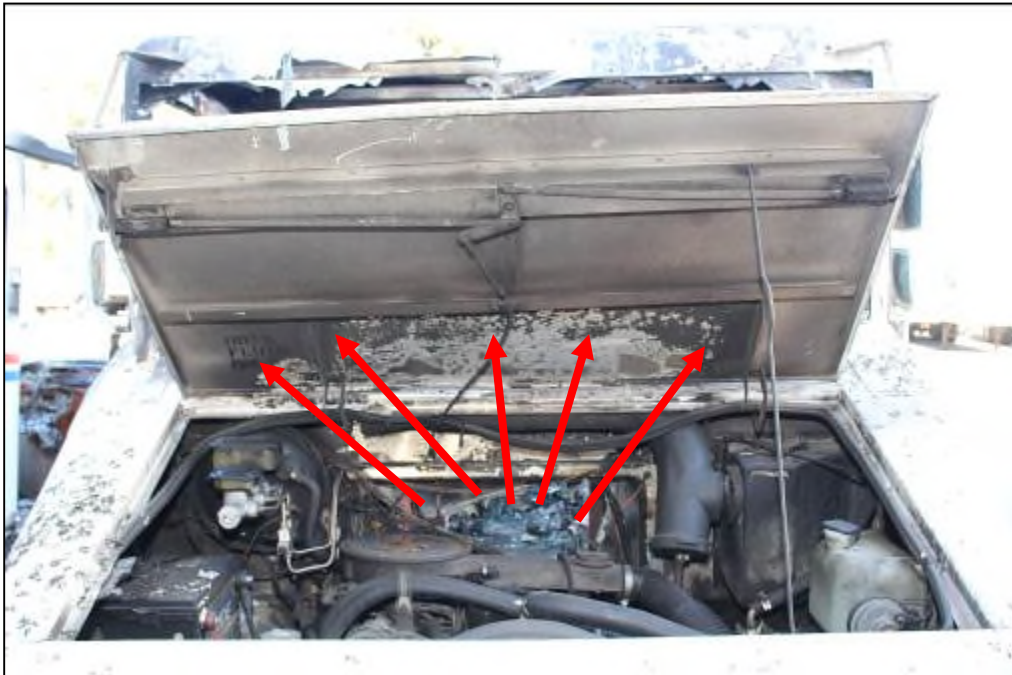
Photograph 9

The engine compartment was examined. Fire damage was observed in the rear area of the engine compartment. The fire had traveled from the passenger compartment into the engine compartment through the manufactured bulkhead openings and through the bulkhead. The fuel system was examined and found to be intact with no damage noted. The fuel filter was intact and located along the rear of the engine near the bulkhead. The fuel system was an AC Delco model. The battery for the vehicle was located at the front right side of the engine compartment and had no fire damage. The engine oil and transmission fluid were examined and observed to be within their normal operating range. Based on the fire patterns, the engine compartment was not the area of origin.

View of the fire patterns extending from the passenger compartment into the engine compartment.

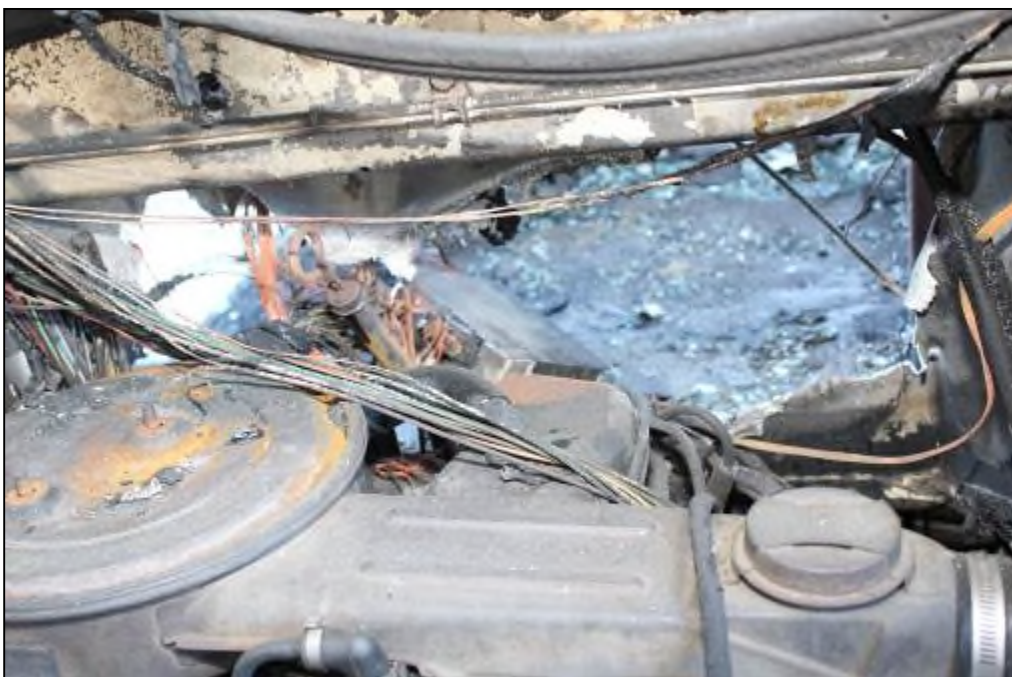
Photograph 10

View of the fire penetration through the bulkhead from the passenger compartment into the engine compartment.

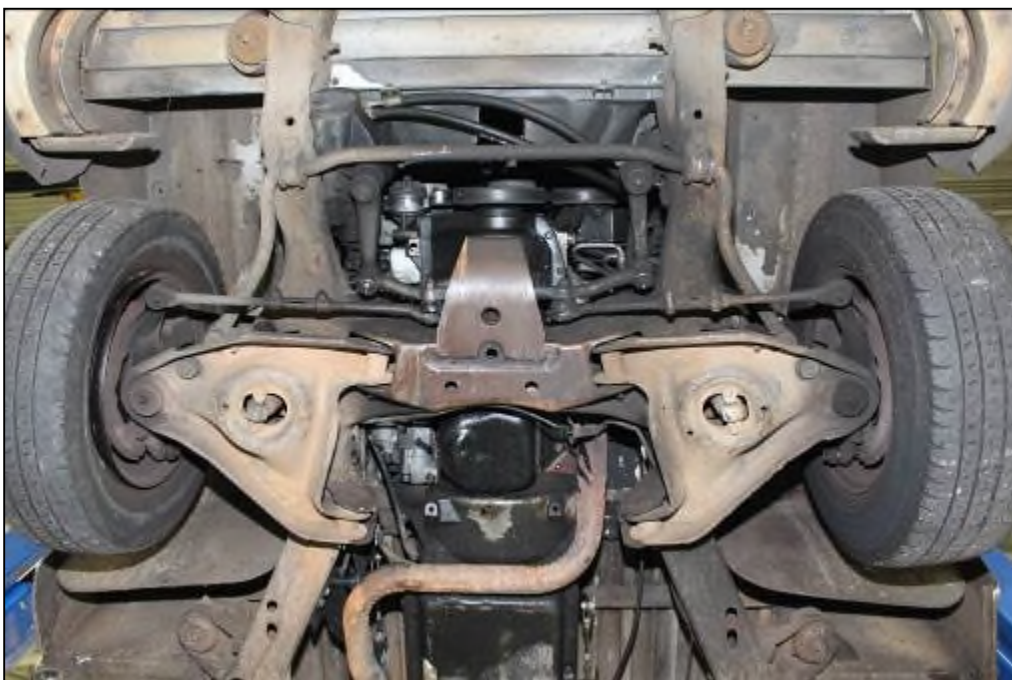
Photograph 11

Examination of the undercarriage revealed no damage. The LLV was mounted on a GM frame and was undamaged. The fuel tank and fuel lines did not show any signs of failure. The exhaust system was intact and the transmission did not reveal any leaks.

View of the undercarriage.

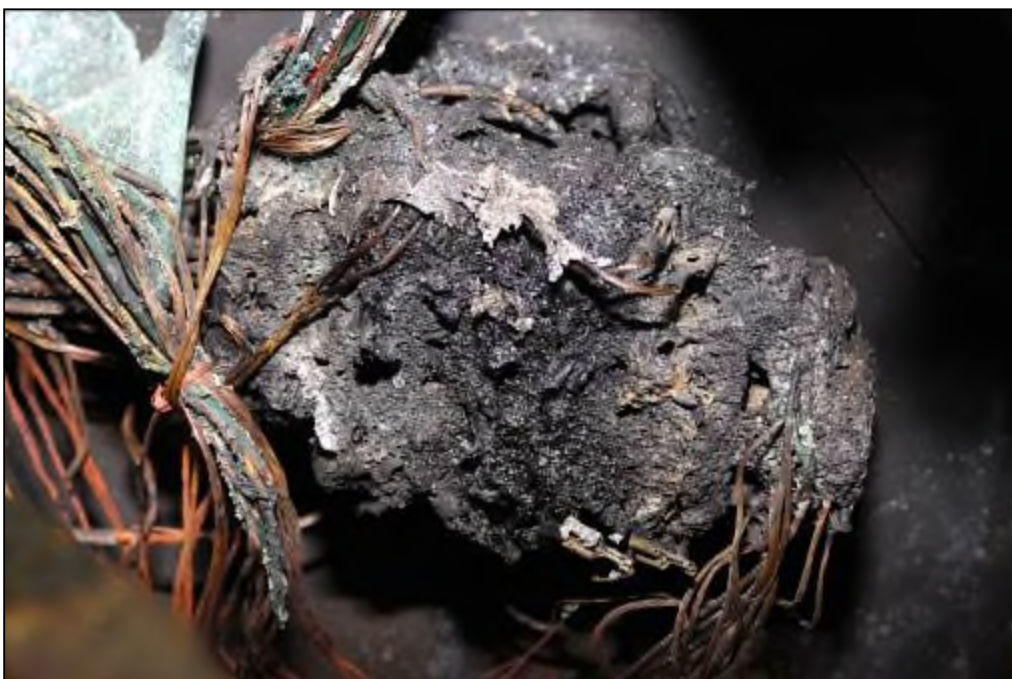
Photograph 12

Examination of the fuse panel revealed that it had sustained severe fire damage. The fire damage observed was a result of the fuse panel being exposed to the fire.

View of the fire-damaged fuse panel.

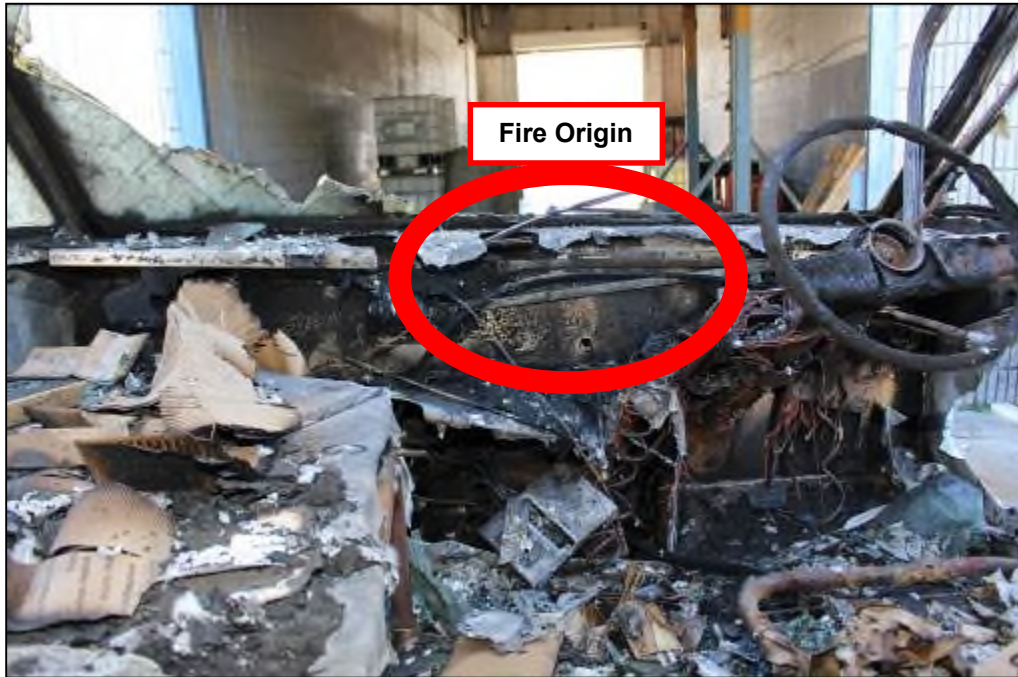
Photograph 13

It is our opinion, based on the observed pattern of fire damage and a systematic evaluation of the remaining physical evidence that the fire originated in the left side of the dashboard area of the vehicle. The specific area of origin is the headlamp switch.

View of the fire origin.

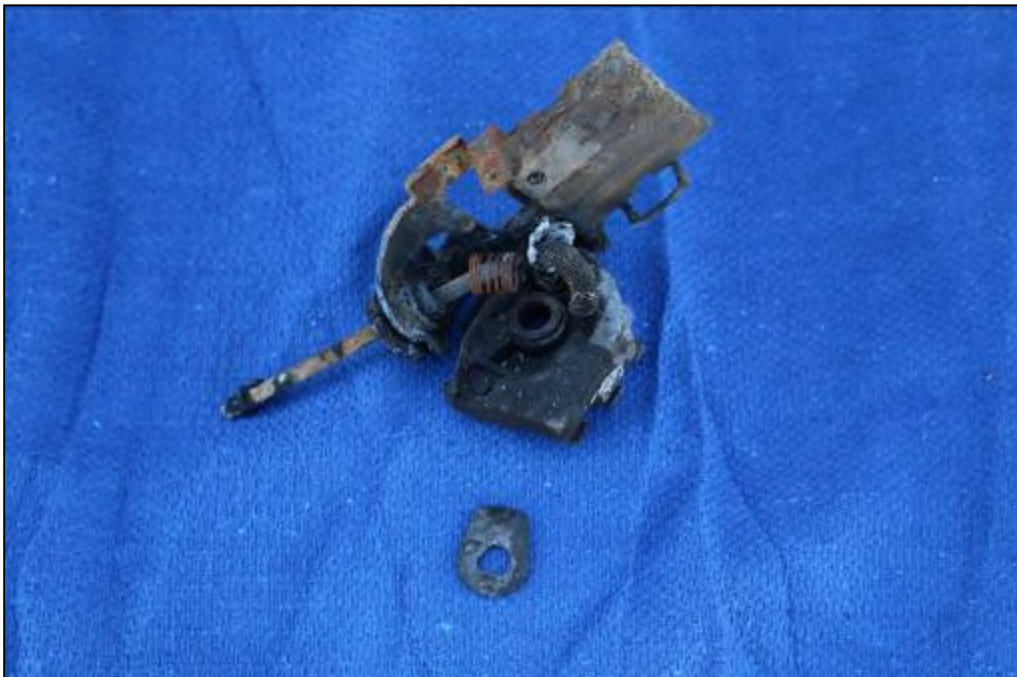
Photograph 14

Examination of the involved headlamp switch confirmed the failure as being the point of fire origin.

View of the headlamp switch assembly collected as evidence.
